DEPARTMENT OF TRANSPORTATION**DIVISION OF ENGINEERING SERVICES**

Contract #: 04-0120F4Cty: SF/ALA Rte: 80 PM: 13.2/13.9File #: 69.15**SOURCE INSPECTION REPORT****Resident Engineer:**Pursell, Gary**Address:** 333 Burma Road**City:** Oakland, CA 94607**Report No:** SIR-001906**Date Inspected:** 12-Mar-2010**Project Name:** SAS Superstructure**OSM Arrival Time:** 700**Prime Contractor:** American Bridge/Fluor Enterprises, a JV**OSM Departure Time:** 1900**Contractor:** Zhenhua Port Machinery Company, Ltd (ZPMC), Changxing Island**Location:** Chang xing dao, Shanghai**Quality Control Contact:** Mr. Don Walton**Quality Control Present:** Yes No**Material transfer:** Yes No N/A**Sampled Items:** Yes No N/A**Stock Transfer:** Yes No N/A**OK to Cut:** Yes No N/A**Rebar Test Witness:** Yes No N/A**Delayed/Cancelled:** Yes No N/A**Other:** Coating Inspection**Bridge No:** 34-0006**Component:** See below**Bid Item:** 77, 78, 79**Lot No:** B# 204**Summary of Items Observed:**

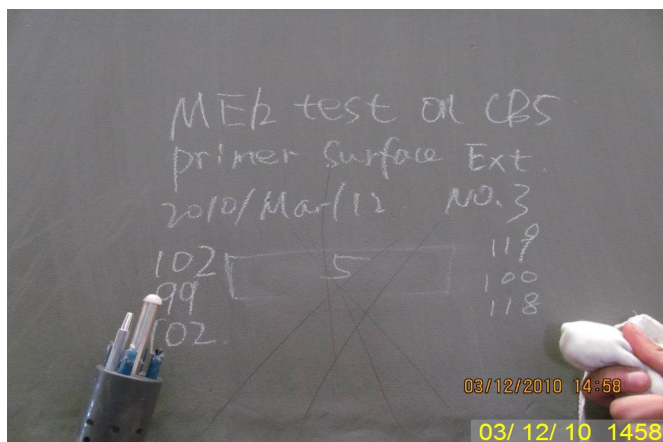
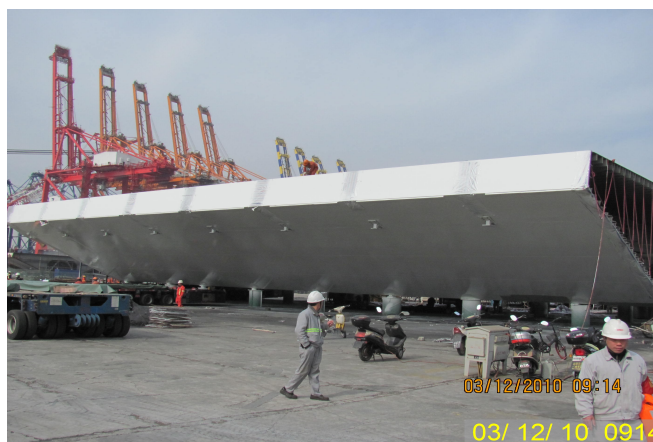
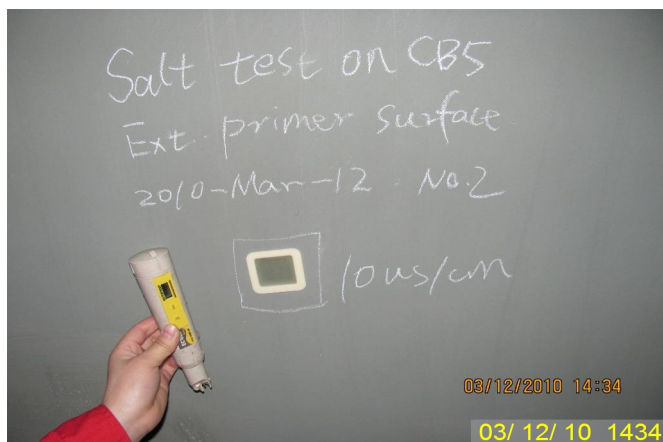
1. An inspection was requested on the Cross beam external and internal surfaces CB6 -1 Set, for Degreasing and cleaning, vide request no. 2846 at North west Corner for the OBG Fabrication Workshop. This Caltrans inspector observed, ABF inspectors Mr. Wei, performing Degreasing and Cleaning inspection of external and internal surfaces which was accepted after ZPMC personnel attended some of the cleaning works in Hole areas.

2. An inspection was requested on OBG External surface Lift 5 -L5E & L5W except the cross beam Bottom plate at OBG assembly yard, vide inspection request no. 2847A. This Caltrans inspector observed, ABF inspectors Mr. Don Walton, Mr. Turtle performing DFT check and the results found to be in the range of 234 to 275 which is acceptable as per contract documents. Mr. Bill Howe from Caltrans were present during the Inspection process and final acceptance for finish coat application were given by him. International protective coatings technical service representative Mr. Li peng was found present during the course of this inspection process.

3. An inspection was requested on the OBG internal entire floor from P.P32 to P.P33 to P.P 34 and OBG cross beam terminal internal surface for DFT Check of primer coat at OBG assembly yard, vide inspection request no. 2848. This Caltrans inspector observed, ABF inspectors Mr. Wei and Mr. Turtle rejected the same as it was found not meeting the minimum requirement in some of the places. International protective coatings technical

4. An inspection was requested on the Cross beam (CB5) external surface for DFT Check of primer coat, Residual chlorides test and MEK Test vide inspection request no. 2850. This Caltrans inspector observed, ABF inspectors Mr. Wei, Mr. Shi stone, Mr. Sun and Mr. Turtle performing the above mentioned Inspections. The results of MEK Test found in the range of Grade 4 & 5 which is acceptable as per contract documents. The results of Residual chlorides test found to be 10 and 20 us/cm which was measured by ZPMC QC Inspectors.(Photo of MEK Test result and residual chloride test is attached). International protective coatings technical service representative Mr. Li peng was found present during the course of this inspection process. The ambient conditions found to be 5.8 deg. above dew point and the relative humidity found to be 66.1% outside the paint shop which is found to be within the parameters of contract documents.
